Manhole Inspection Summary

Manhole # S45II_047MH

Location Address: **Washington St**

Cross Street: **Oliver St**

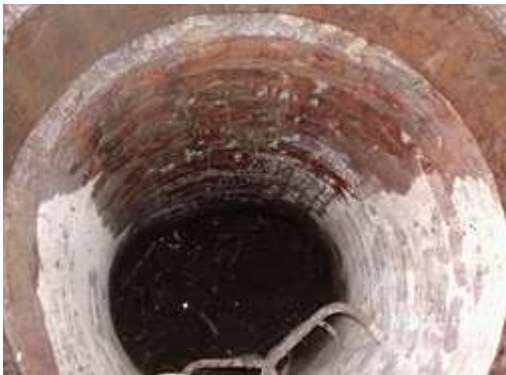
Defect 2

Frame Leaks

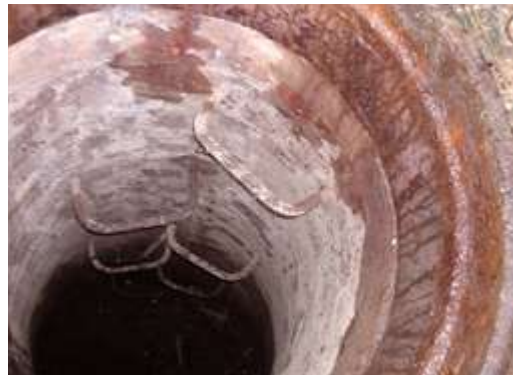
Defect 1

Infiltration: ☐ None ☐ Joint ☐ Cracks ☐ Mortar ☐ Roots ☒ **Wall**

Infiltration

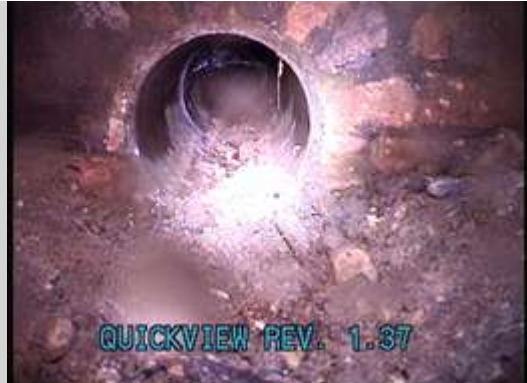
12 O'Clock Outflow

8 in. Circular Gravity Sewer
Pipe Out @ 12 O'Clock

Deposits: ☐ None ☐ Mud ☐ Sludge ☒ **Debris** ☐ Grease

Silt Depth: **1** (in.) Deposits Extent: **Light**
